Locating NEXT Problems

This article describes how to locate the source of a failure of Near End Crosstalk (NEXT) when doing copper cable certification. We will start with the assumption you have run a cable certification test and now want to see whether your NEXT results are due to a specific point in the link (often a connection) or whether the NEXT issue is distributed throughout the link (means the cable is the problem).

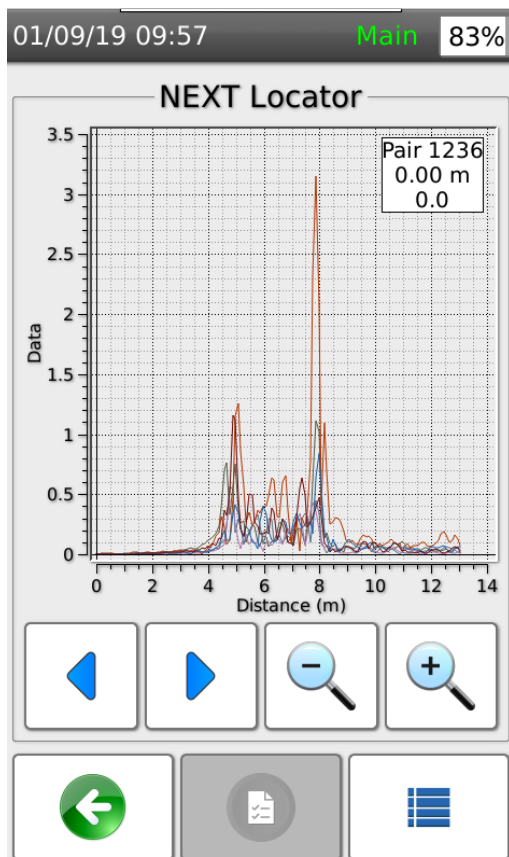
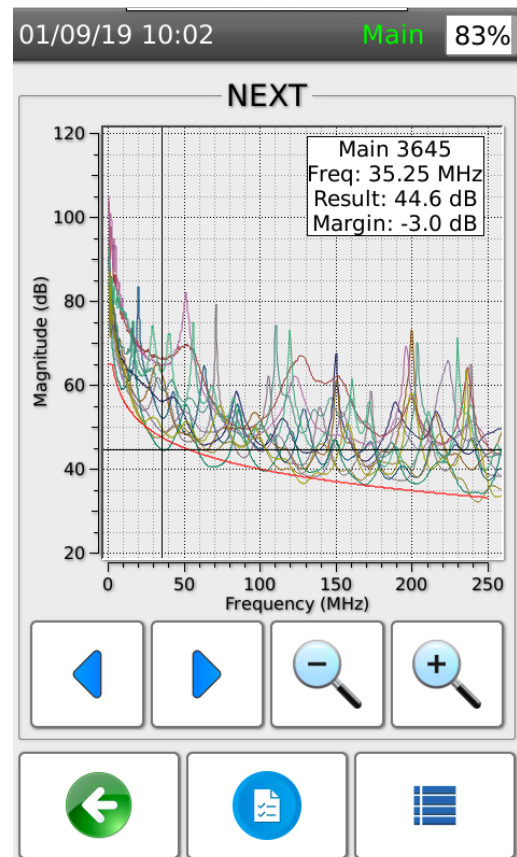
4. Test Result Screen

Note that the TestPro also provides a full graph of the NEXT performance. You can see in the example below that the NEXT crosses the pass/fail line at several frequencies. This data is helpful for expert users but will not help the average user find the location of the NEXT failure so it can be repaired.
